**CR 通 報**  
**CR NOTICE**

NO. : CR-2025-002(S)

Date : Feb. 24, 2025

**TO** : 所有船東、驗船師、航港局船舶組及各航務中心  
**FROM** : 台北總部  
**SUBJECT** : 2025 年澳洲 PSC 檢查，有關艙蓋與領港梯等缺失項目之重要注意事項

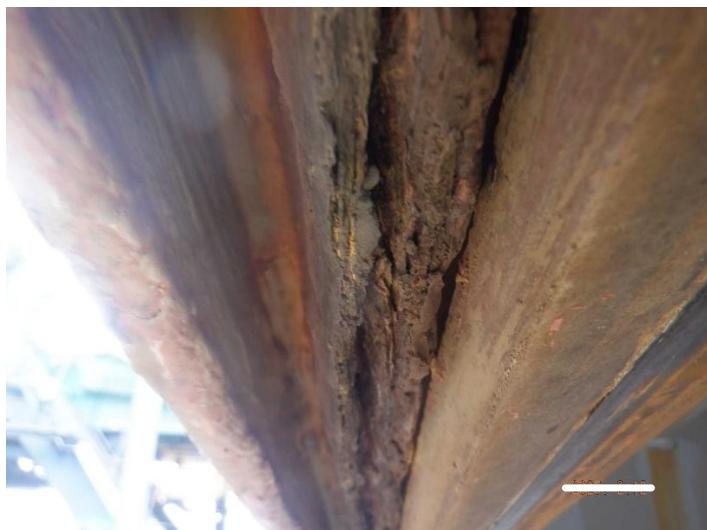
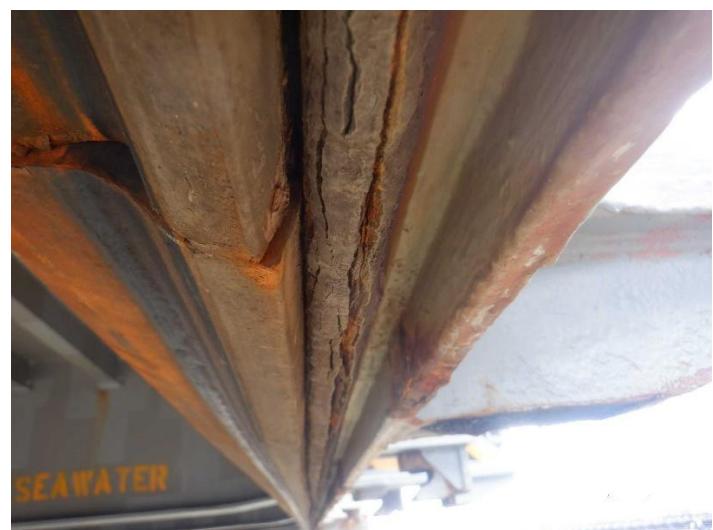
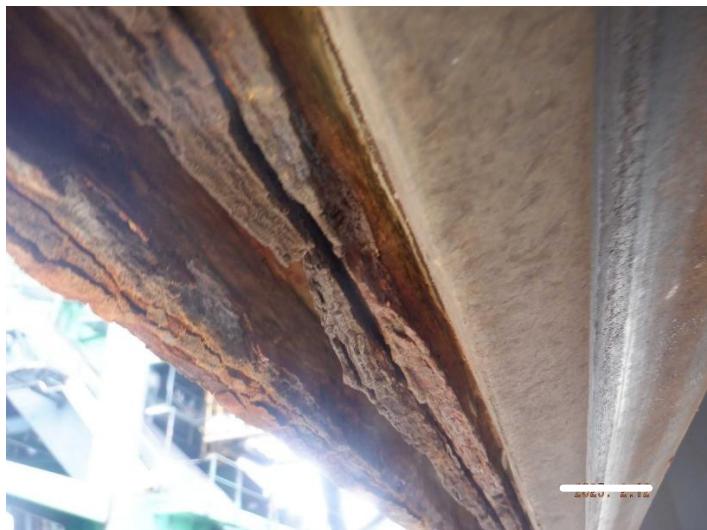
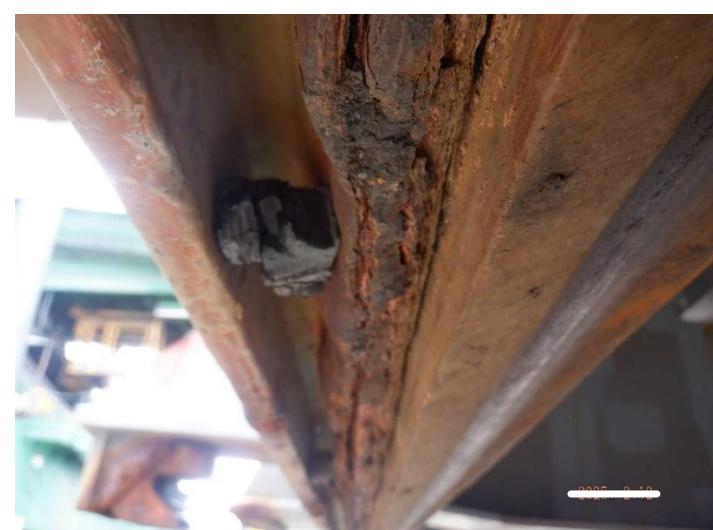
船上艙蓋現況照片

- 一 近期一艘散裝船於澳洲格拉德斯通(Gladstone)港遭 PSC 開立五項缺失，其中有二項缺失分別因船端未妥善保養維護導致主甲板上的艙蓋狀況嚴重惡化和領港梯缺損。PSC 檢查報告如附件一，艙蓋照片如附件二。
- 二 澳洲海事局曾發布通告 Marine Notice 10-2022(如附件三)，到訪澳洲各港口船上計畫性保養是持續關注的議題，不是有期限的重點檢查活動。提醒散裝船船東須依據 SOLAS Reg. XII/7.2 且建議參考 MSC.169(79)「散裝船艙蓋船東檢查和維護標準」(如附件四)，確實維護艙蓋設施。
- 三 對於領港上、下船舶的布置標準和領港梯檢查的要求，請船東及其所屬船隊於前往澳洲前依其海事通告 Marine Notice 2023/04(如附件五)，確實檢查並維護領港登離船布置，特別是領港梯需符合 ISO 799 有關 30 個月強度測試 (Strength test)之要求。
- 四 另外，本次澳洲 PSC 檢查報告中顯示，PSCO 檢查過程中對於船員在船進行各項作業而未穿戴適當的個人防護裝備(Personal Protective Equipment, PPE)時，亦會將其列入檢查缺失，請船東確實要求船員遵守公司各項作業安全相關規定。

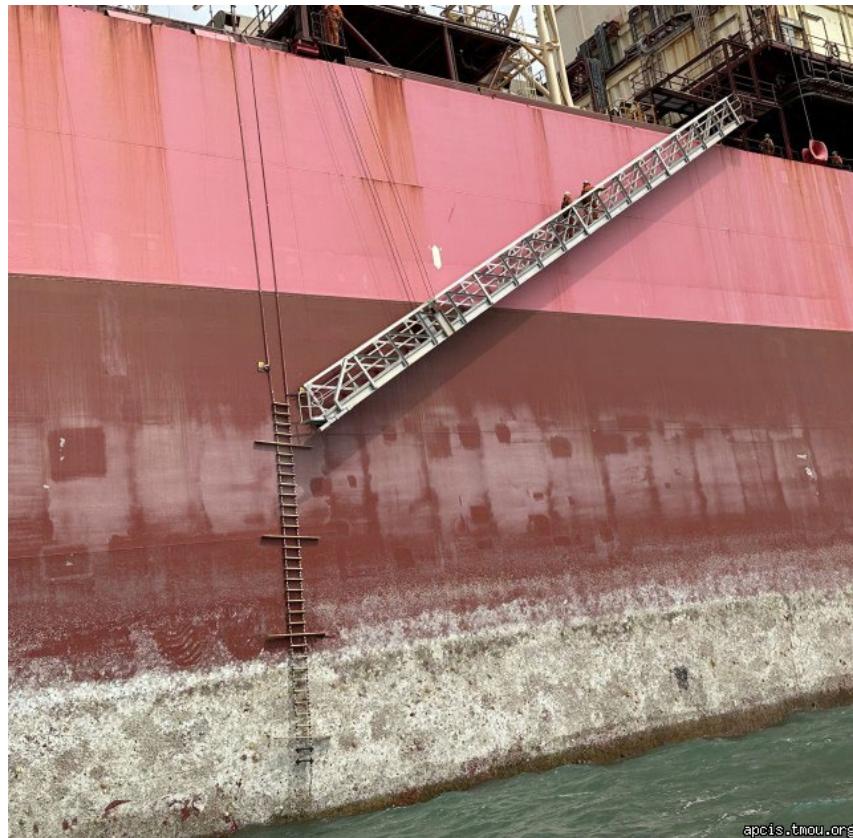
One common issue found is that the pilot ladder does not extend the required 2.0 m past the accommodation platform when a combination arrangement is used. Photo 2 illustrates an example of a pilot ladder not extending the required height past the platform.

*Photo 2: Example of non-compliant combination pilot ladder arrangements.*

As shown in photos 2 and 3 persons cannot climb the pilot ladder to a level where they can move safely onto the accommodation ladder.

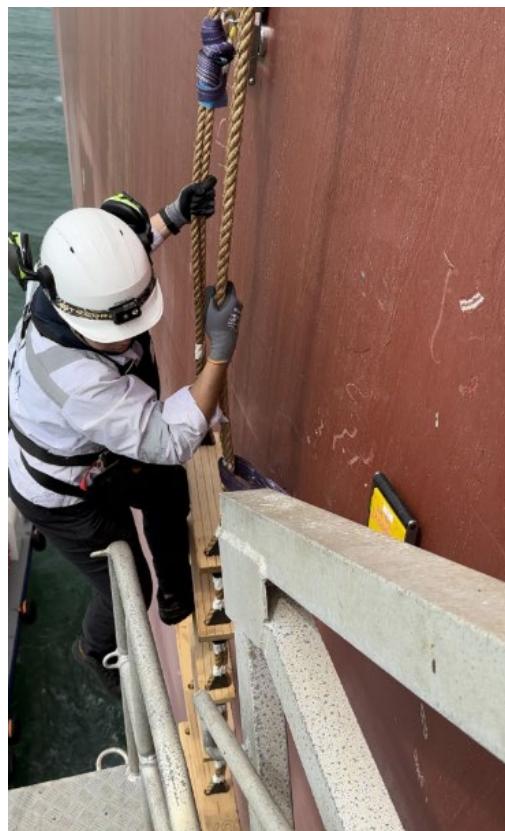
*Photo 3: Person unable to safely access accommodation ladder platform from pilot ladder.*

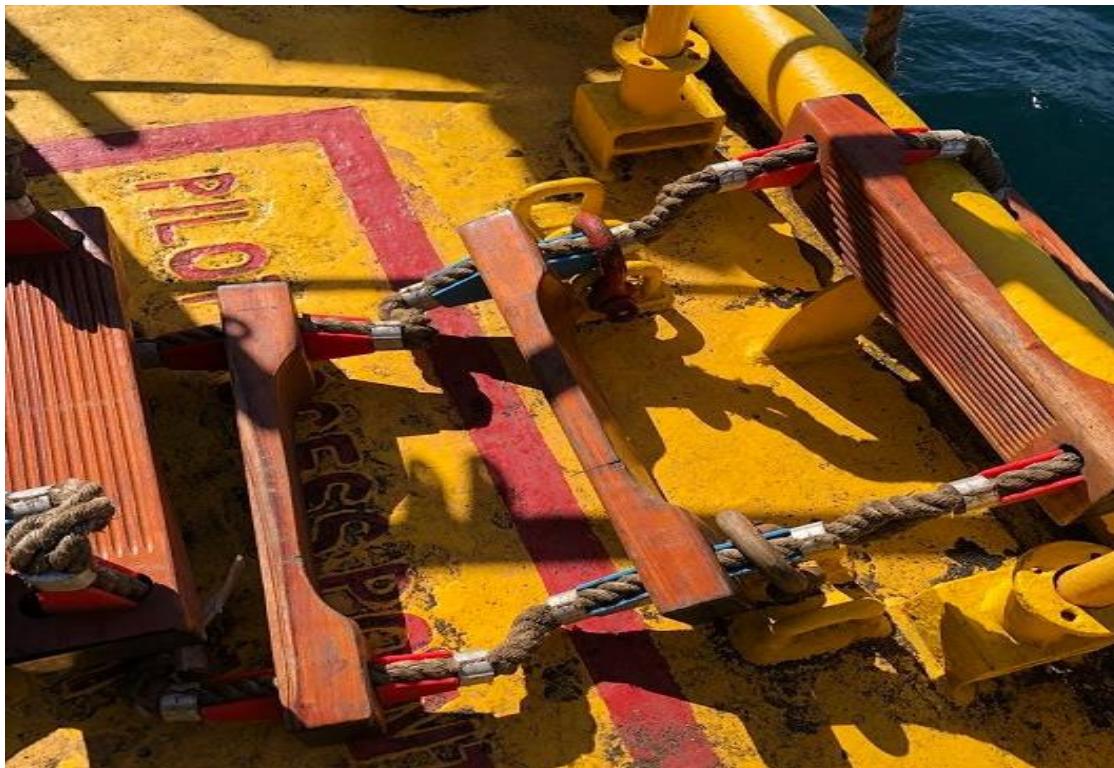
Photo 4 shows an example of an unsafe use of shackles to secure pilot ladders.

*Photo 4: Unsafe pilot ladder securing arrangements (Reproduced with permission from Fremantle Ports).*

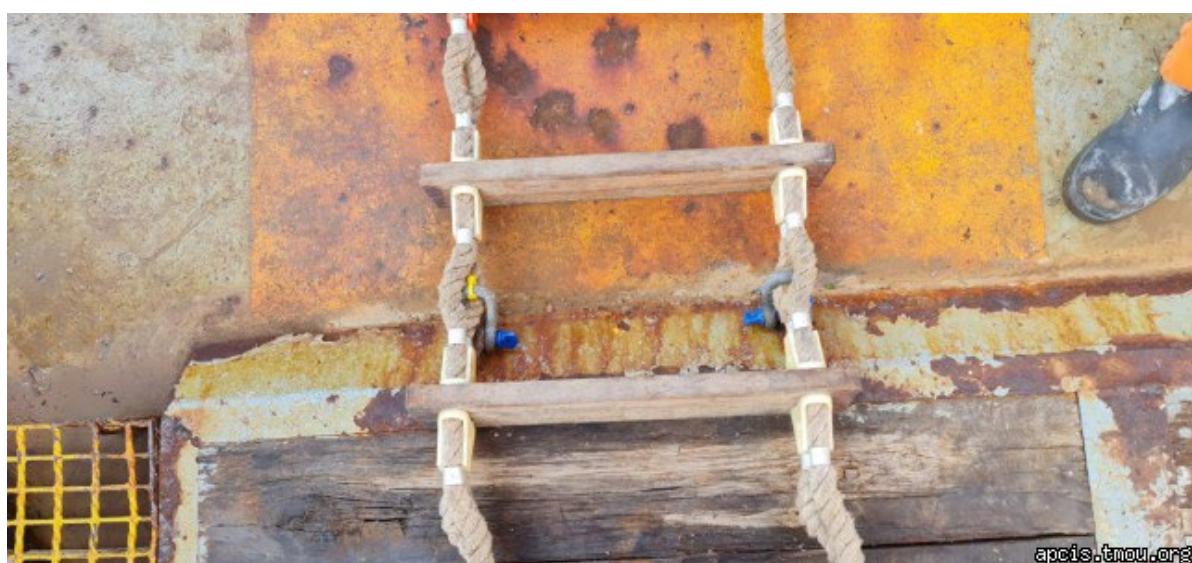
*Photo 5: Unsafe pilot ladder securing arrangements.*

Photos 5 shows the pilot ladder being secured to the strong point by using a shackle passed through the pilot ladder side ropes. This puts increased load on the single part of the side rope and the chock securing arrangements.

It is common industry practice to use a rope stopper usually in the form of a rolling hitch knot between the pilot ladder sides ropes and the approved strong point on the main deck. This will transfer the weight of the ladder arrangement directly onto the designated strong point and will not damage the ladder.

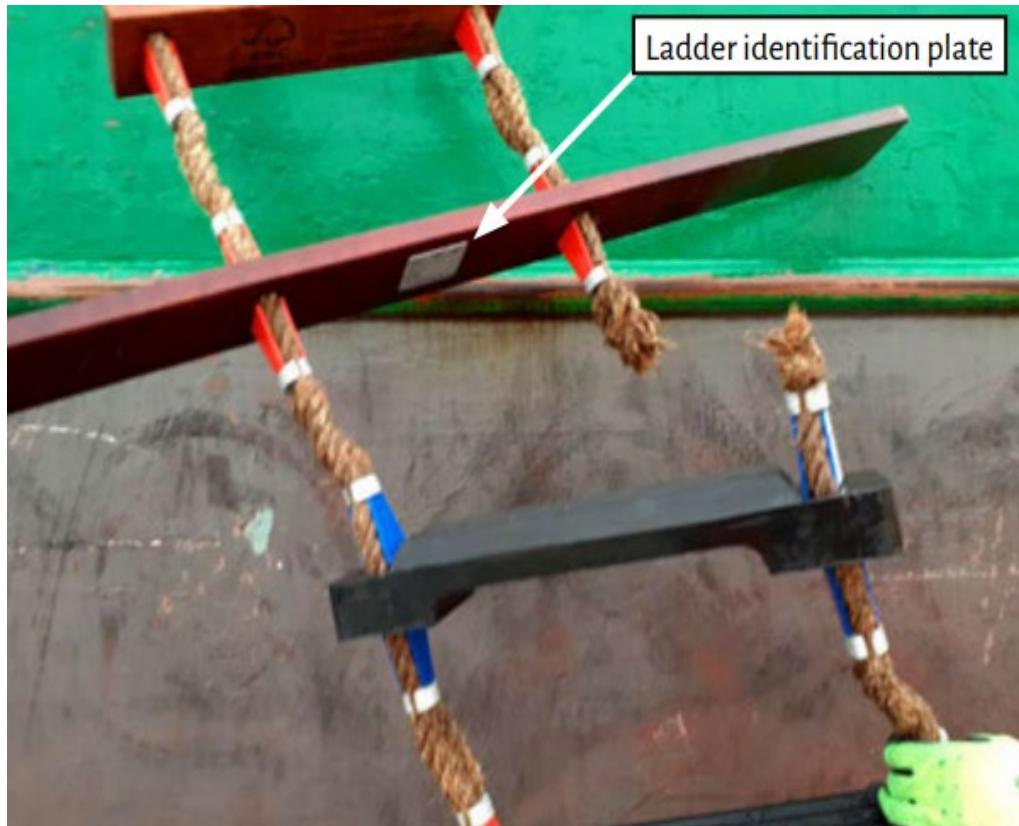
*Photo 8: Pilot ladder where side ropes parted when in use (Reproduced with permission of the MAIB).*

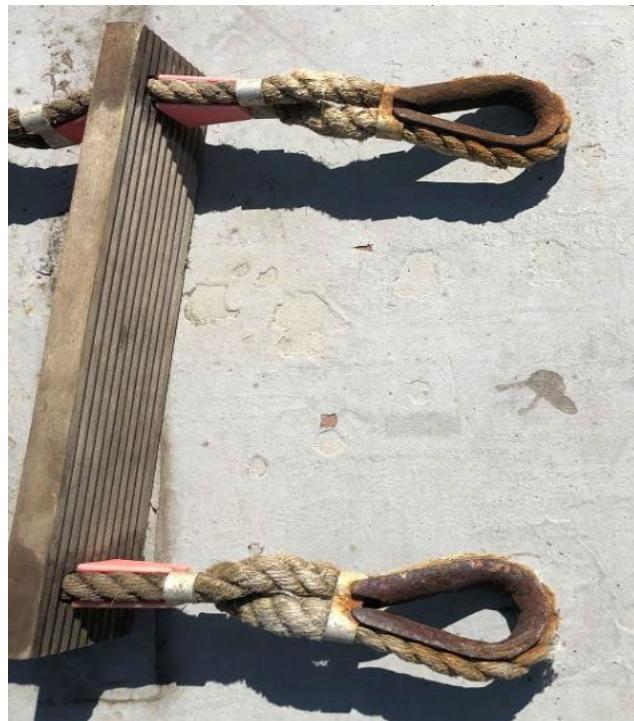
Common areas of defects can be the thimble ends of the pilot ladder. Corroded end point thimbles as illustrated in photo 9, can damage the side ropes leading to failure.

*Photo 9: Example of corroded end point thimbles (Reproduced with permission from Fremantle Ports).*

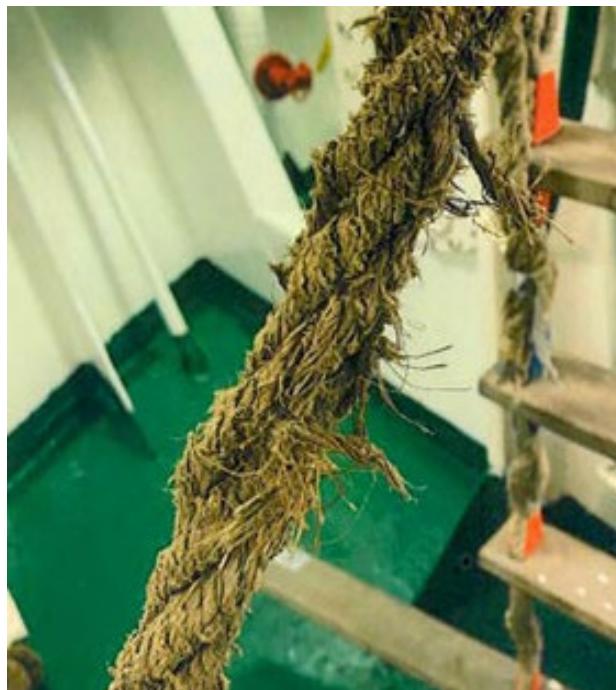
Another common area is the frayed or damaged side ropes as illustrated in photo 10. These should be detected during routine visual inspections.

*Photo 10: Frayed side rope.*

If side ropes are frayed, or in any way degraded the ladder should not be used.

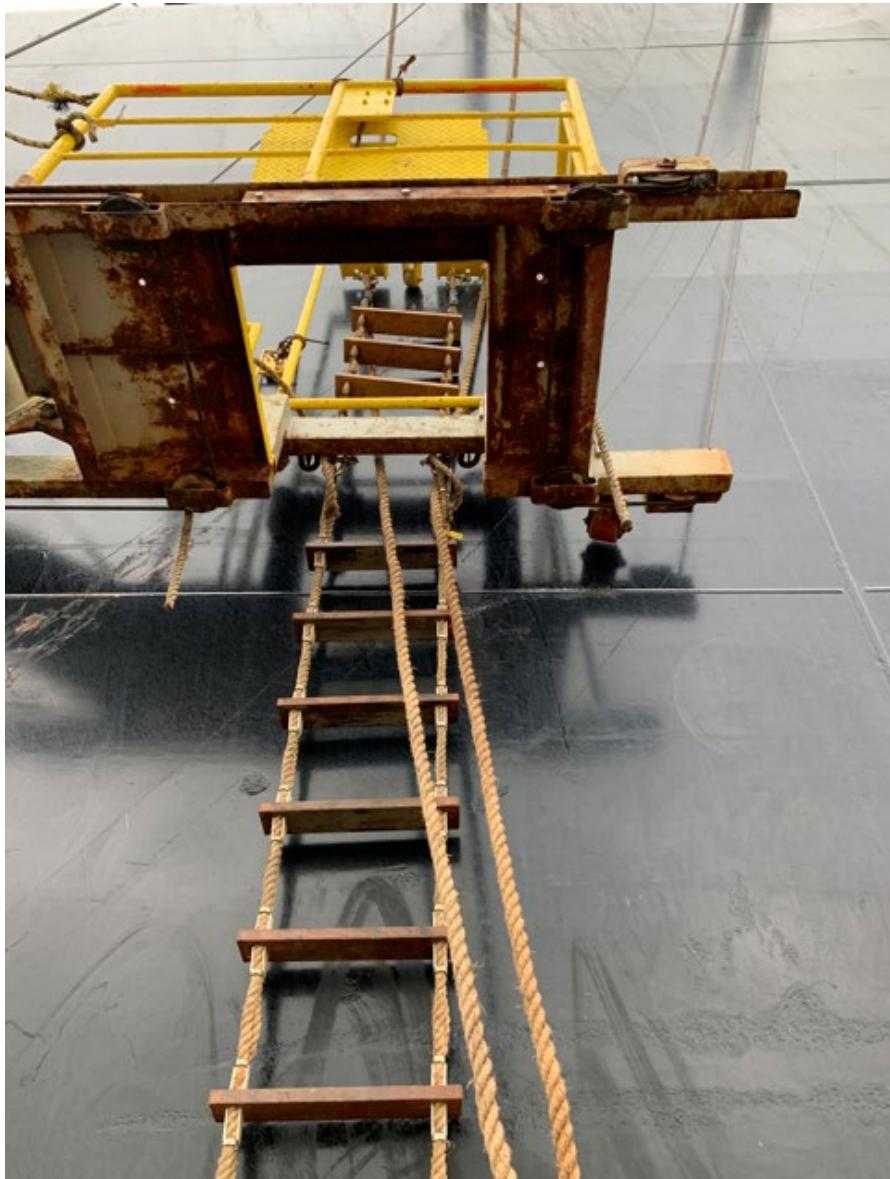
If the pilot ladder and man ropes are not rigged through the trapdoor this creates an unsafe arrangement for persons as illustrated in photo 11

*Photo 11: Unsafe trapdoor pilot transfer arrangement.*

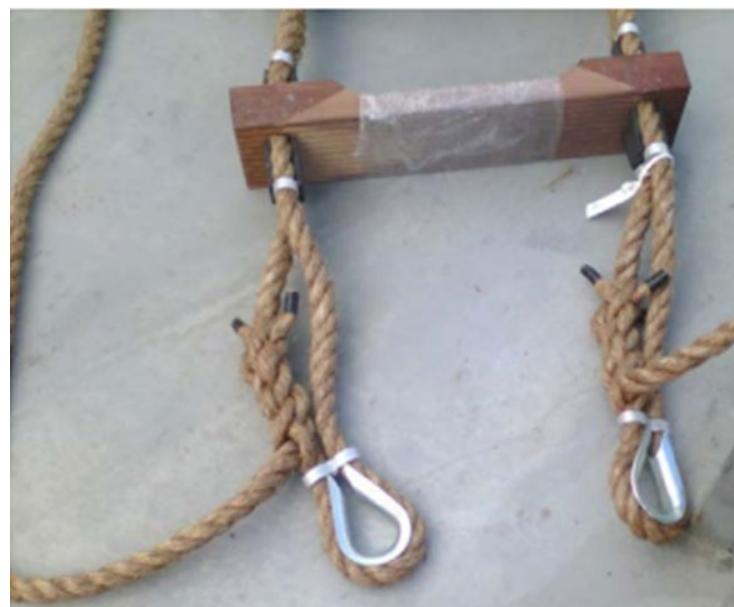
During recent PSC inspections AMSA surveyors have noted pilot ladders which have been constructed with splices in the side ropes.

Photo 12: Example of non-compliant pilot ladder with splices in side ropes.

Pilot ladders constructed like this are considered non-compliant by AMSA. Ship operators and masters are recommended to check their pilot ladders for splices in the side ropes. It should be noted by operators coming to Australian ports that the availability of compliant pilot ladders is limited in Australia. To prevent avoidable delays operators are recommended to have spare compliant pilot transfer arrangements onboard.
