**CR 通 報**  
**CR NOTICE**

NO. : CR-2025-002(S)

Date : Feb. 24, 2025

**TO** : 所有船東、驗船師、航港局船舶組及各航務中心  
**FROM** : 台北總部  
**SUBJECT** : 2025 年澳洲 PSC 檢查，有關艙蓋與領港梯等缺失項目之重要注意事項

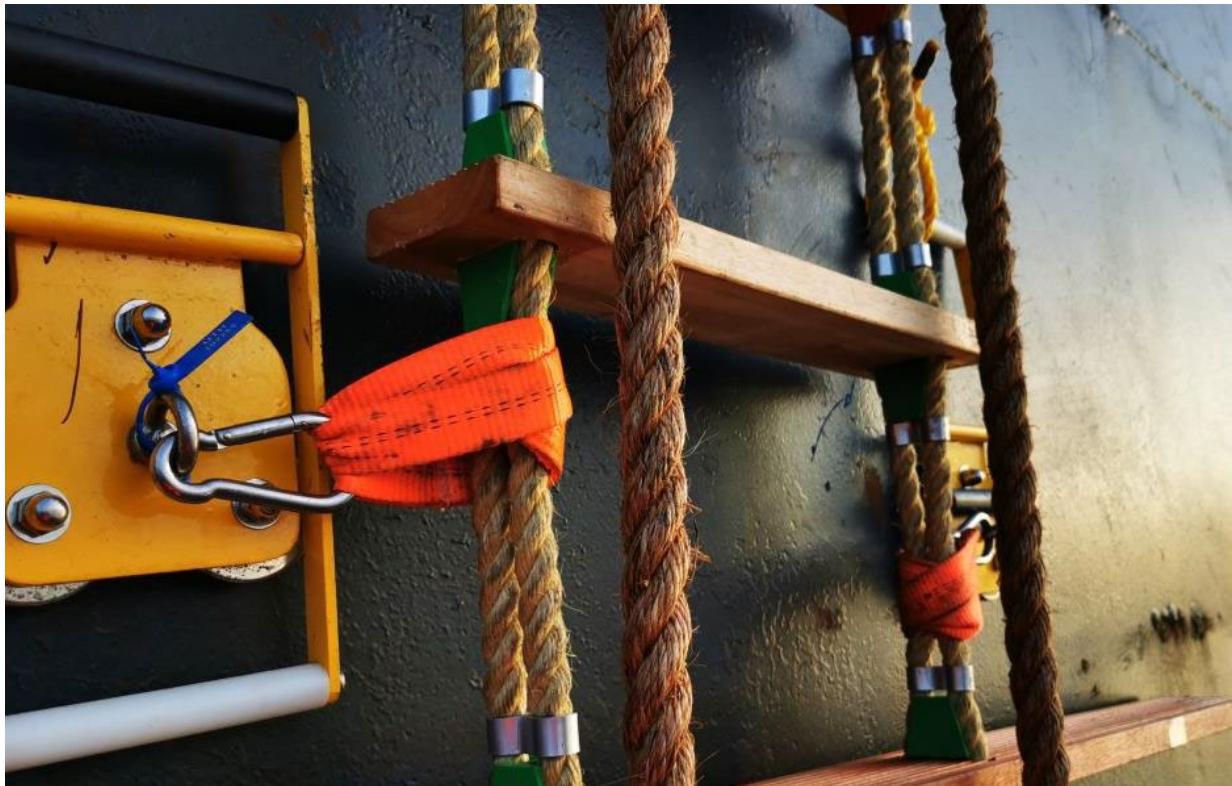
When using a combination pilot ladder arrangement, the pilot ladder and accommodation ladder are required to be secured to the ship's side. A common means of securing both the pilot ladder and accommodation ladders is with magnetic pads (refer to photo 1 below as an example).

*Photo 1: Example of securing both the pilot ladder and accommodation ladders with magnetic pads (Reproduced with permission from Fremantle Ports).*

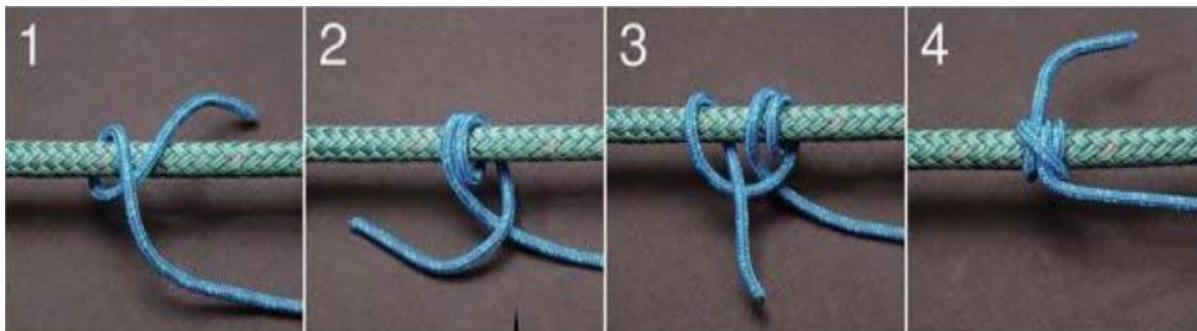
It is suggested that two strong (at least 2 x 24 kN) manila ropes be used to secure the pilot ladder. Photo 6 illustrates a method of tying a rolling hitch knot.

*Photo 6: The rolling hitch knot. (Reproduced with permission from Fremantle Ports).*

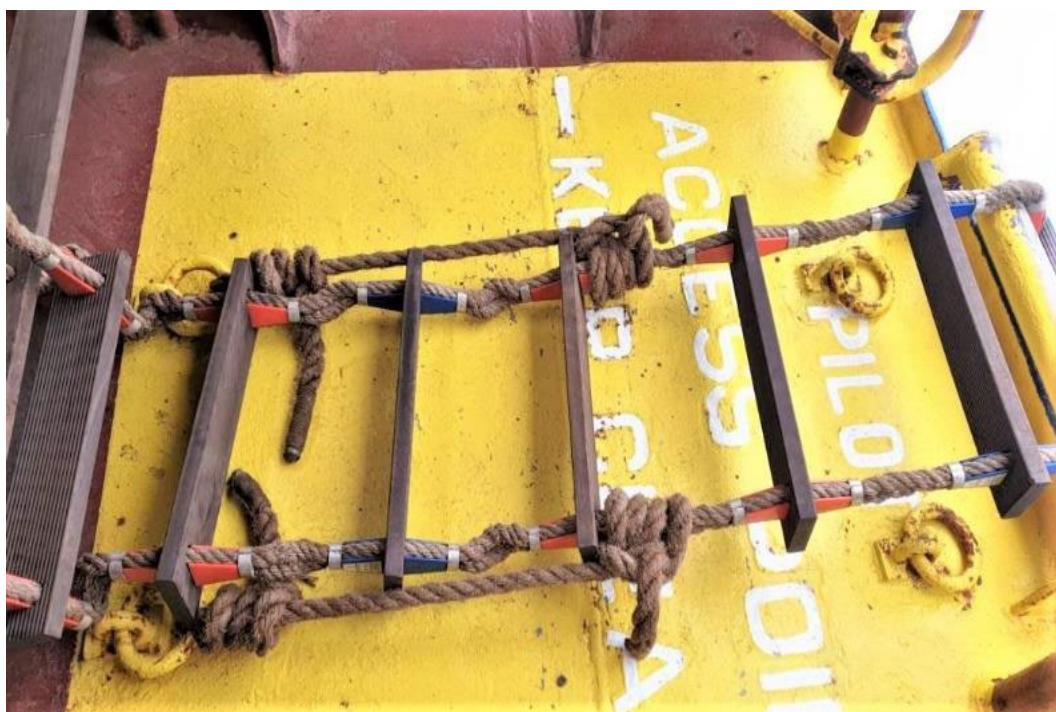
Photo 7 provides an example of rolling hitch knots being used to secure pilot ladders to approved main deck strong points.

*Photo 7: Rolling hitch knots being used to secure pilot ladders to approved main deck strong points (Reproduced with permission from Fremantle Ports).*

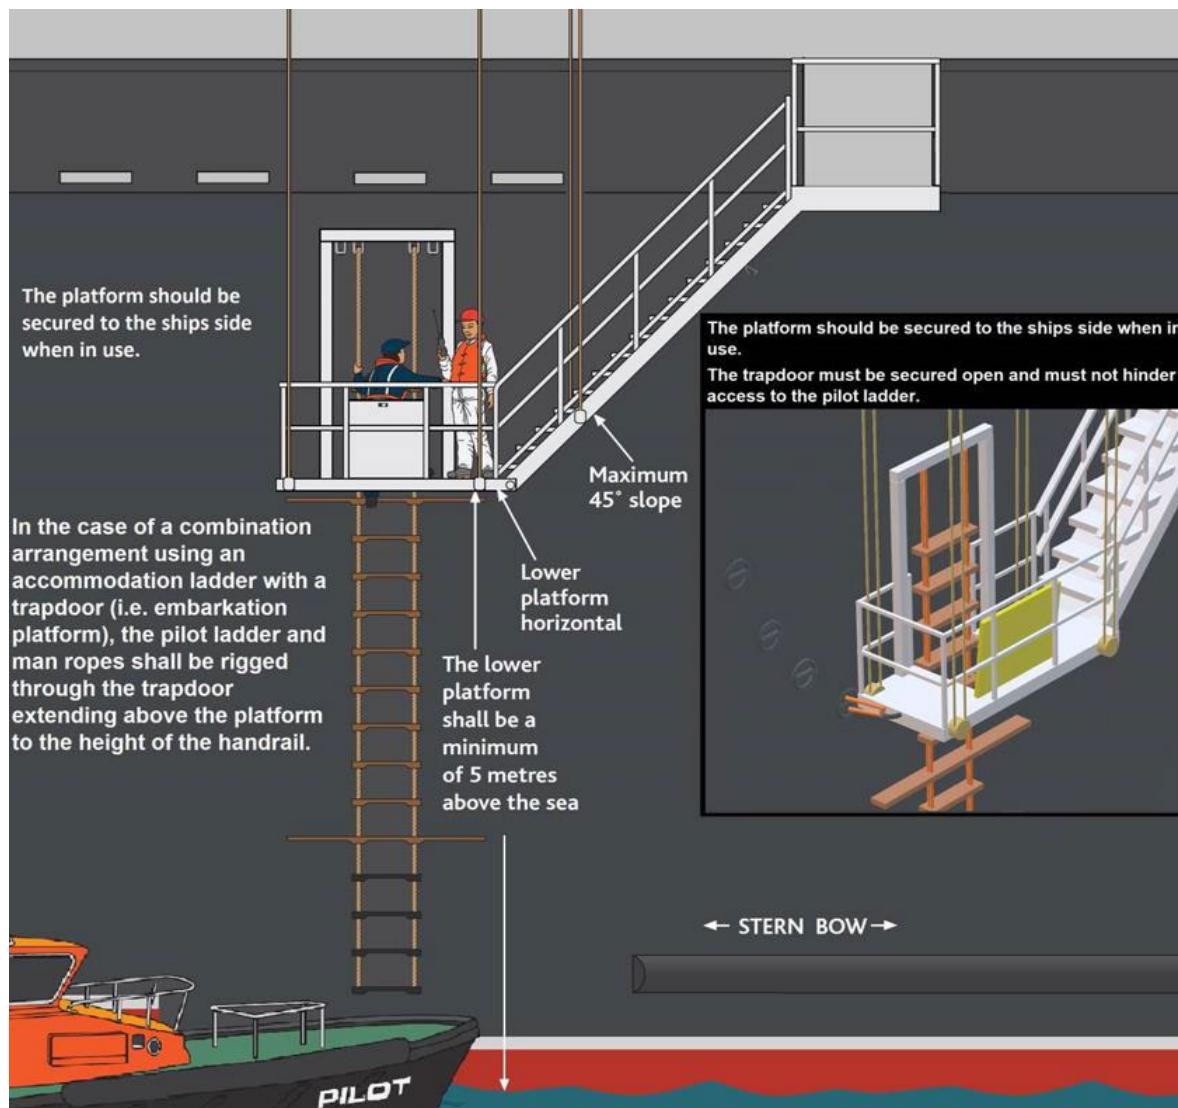
There has been an increase in ships fitted with trapdoor arrangements. The additional requirement for their use is "the pilot ladder and man ropes shall be rigged through the trapdoor extending above the platform to the height of the handrail".

Figure 1: Pilot card depicting trap door arrangements.
