# 中國驗船中心 China Corporation Register of Shipping

## 技術通報 TECHNICAL CIRCULAR

編號 27  
日期 2006.5.10

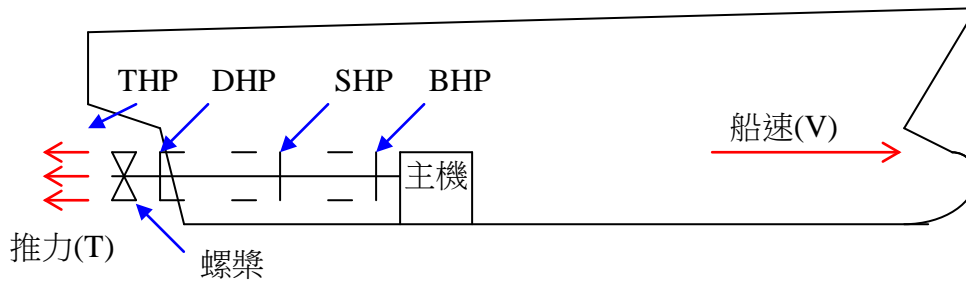
## 一、船舶推進效率示意

$$\begin{aligned}
 \text{推進效率} &= \frac{\text{總阻力} \times \text{船速}}{\text{主機出力}} = \frac{EHP}{BHP} = \frac{R_T \times V}{BHP} \\
 &= \frac{DHP}{BHP} \times \frac{THP}{DHP} \times \frac{EHP}{THP} \\
 &= \frac{2\pi NQ}{BHP} \times \frac{2\pi NQ_0}{2\pi NQ} \times \frac{T \times V_0}{2\pi NQ_0} \times \frac{R_T \times V}{T \times V_0} \\
 &= e_t \times e_r \times e_p \times e_h \\
 &= \text{傳動效率} \times \text{螺槳效率比} \times \text{螺槳效率} \times \text{船殼效率}
 \end{aligned}$$

註一：CSBC Hull No.310, 3000TEU, Speed 21Kts 之案例：當船頭逆風風速為 4.6Kts 時，推進效率為 0.750；若風速為 0Kts，則為 0.752。
